Regeneration of coastal forests affected by tsunami

Forestry and Forest Products Research Institute, Japan

Tomoki Sakamoto

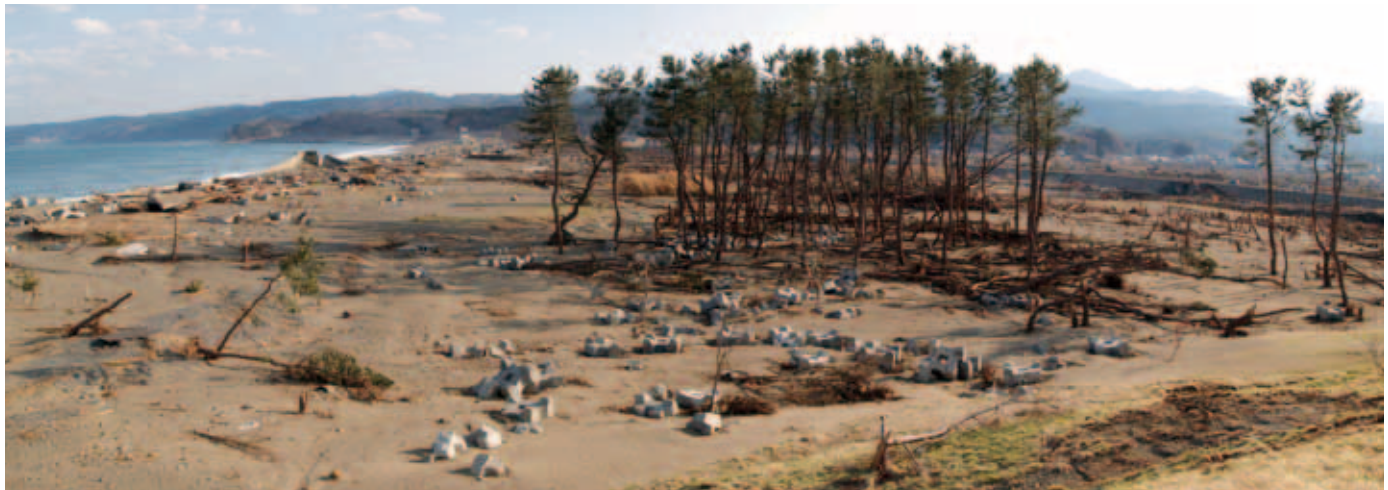
Photo 1

Catastrophically damaged coastal forest (Noda village, Iwate Prefecture)

The coastal forest was lost, leaving only a part. The coastal levee along the shoreline was also destroyed, leaving a part and concrete blocks, and other material entered the inland side. At right rear, there are many stumps with broken stem.

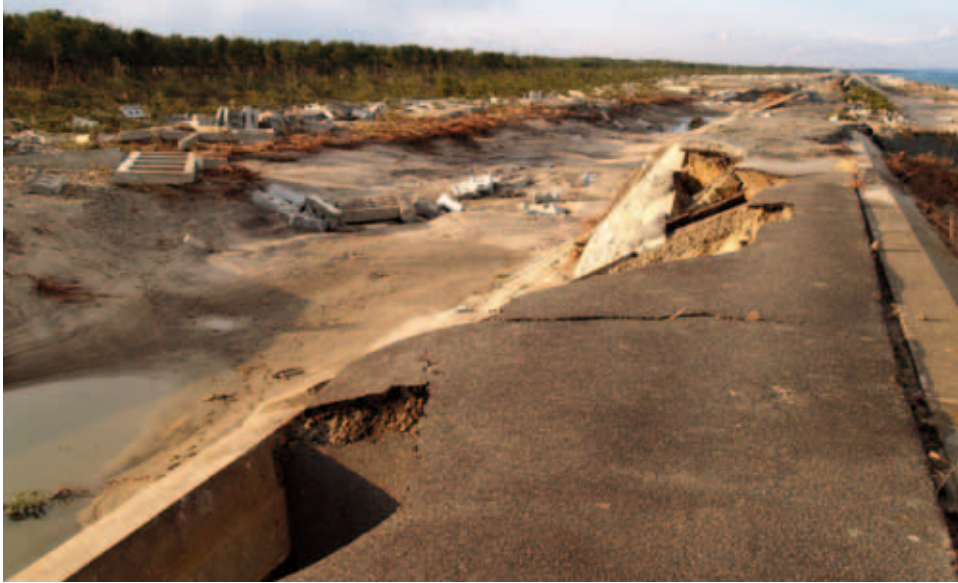
Photo 2

Scouring behind a coastal levee (Iwanuma city, Miyagi Prefecture)

In the coastal forest shown at the upper left, constituent materials of the destroyed coastal levee were scattered and the seaward portion of the forest zone was pushed down.

The 2011 Great East Japan Earthquake (the 2011 Tohoku Pacific coast Earthquake) that caused the tsunami of present interest was a huge earthquake of magnitude 9.0, with its epicenter located off the Sanriku coast. The tsunami that attacked coastal areas in the Tohoku region was never encountered before and was far larger than what people could have imagined. The wave was particularly high in coastal areas in the Iwate Prefecture, wherein the ria coastline had developed; coastal levees were destroyed and forests were devastated in coastal areas affected by the huge tsunami (Photo 1). In the scenic Takatamatsubara in Rikuzentakata city, because of pre-existing ground subsidence, the tsunami damage was not limited to trees but included the land, which was largely washed out and had become a sea. The wave height in the Sendai Plain was not as high as that in the ria coastline, but some inundation heights exceeding 10 m were recorded*. In many places in the Sendai Plain, the tsunami affected coastal levees and scoured the land to create depressions on the inland side of the levees (Photo 2). The coastal levees themselves were also violently destroyed, presumably owing largely to the scouring (Photo 3).

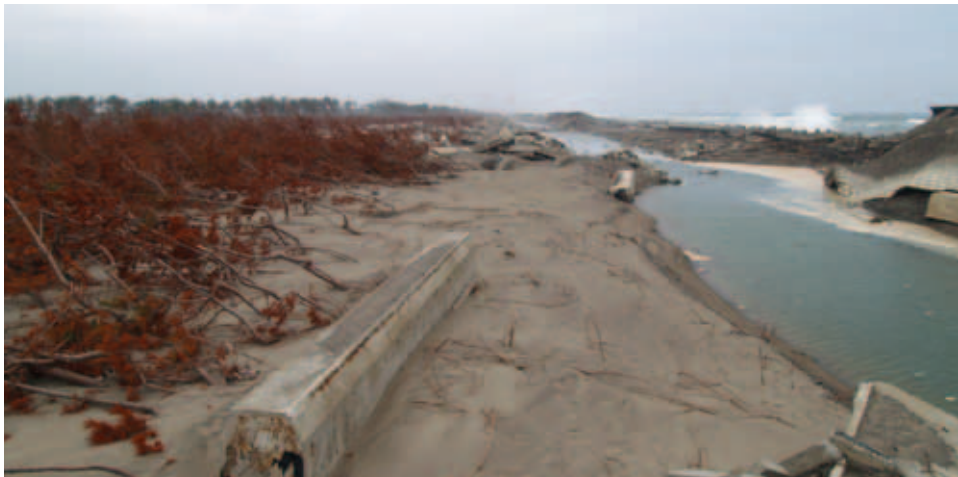
Photo 3

Destroyed coastal levee and scouring behind it (Iwanuma city, Miyagi Prefecture)

The coastal levee was destroyed and the sea surface can be observed. The strip-shaped water surface on the right side is a depression considered to have been scoured by the tsunami that overflowed the levee. Concrete pieces at the front and white objects in the center are constituent materials of the damaged coastal levee.

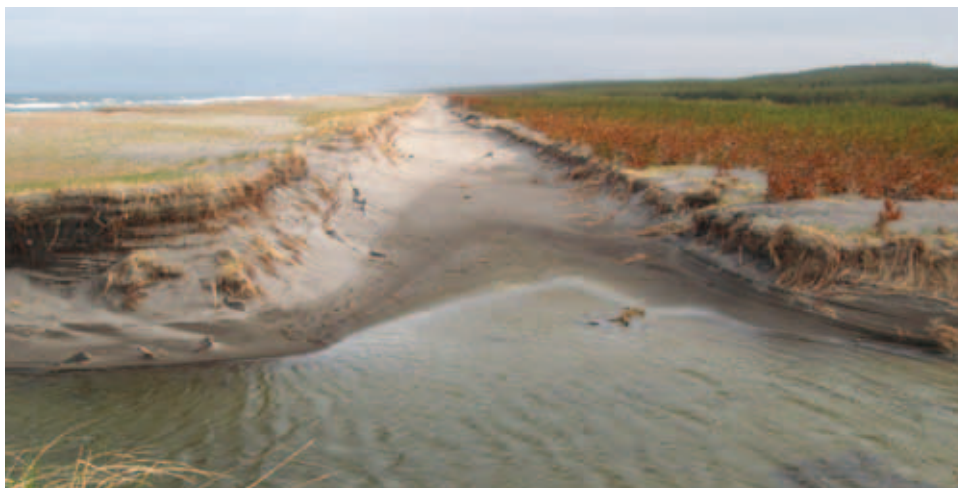
Photo 4

Artificial dune washed away (Misawa city, Aomori Prefecture)

There was an artificial sand dune in a depression vertically extending in the center. It is believed that the back of the artificial dune was sequentially eroded from the inland side by the tsunami that overflowed the artificial dune and was finally lost.

A phenomenon similar to the scouring on the inland side of the coastal levees also occurred in an artificial sand dune (Photo 4). Furthermore, there were some places that had been coastal forests but became seas, presumably because the topsoil was washed away mainly by the backrush (Photo 5).

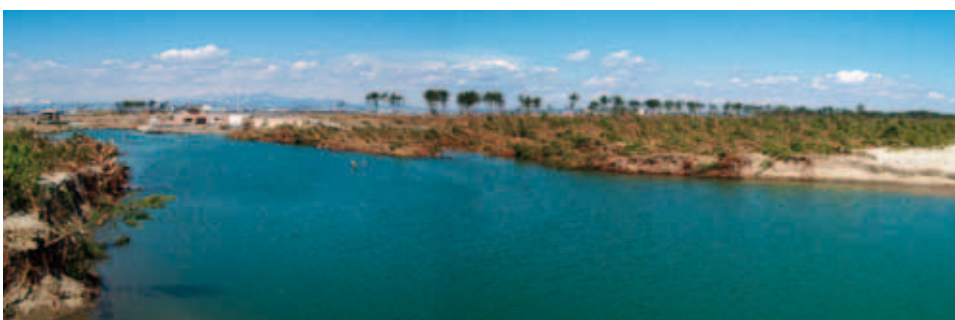
Photo 5

Washout of land (Sendai city, Miyagi Prefecture)

There appears to be a river, but the two sides of the coastal forest were linked before the tsunami. The coastal forest is considered to have been divided by scouring because of focused backrush.

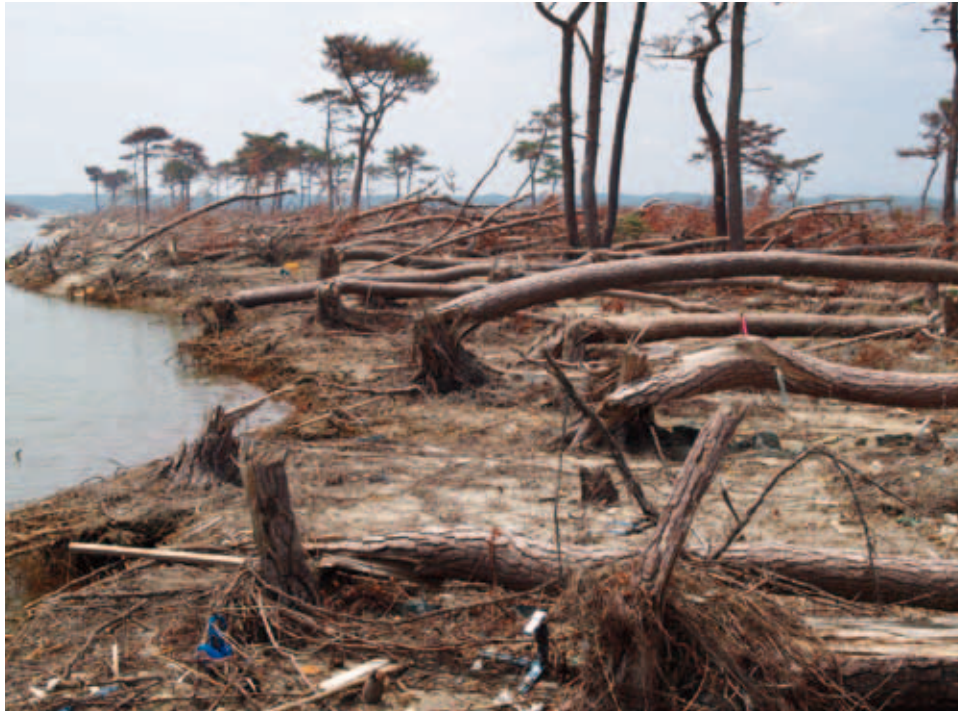
Photo 6

Stem breakage (Soma city, Fukushima Prefecture)

The broken stem remained connected to the stump in some cases or was washed away in other cases. The state of the breakage edge also is not uniform.

“Stem breakage” refers to a broken stem (Photo 6). Although stems of some trees appeared to be just bent without being completely broken, cracking was confirmed inside the stems. Among trees with broken stems, the stem was completely separated from the stump in some trees or connected to the stump with bark or other tree parts. If only the stump was left without the stem being attached to it, it meant that the upper part (stem) had become driftwood.

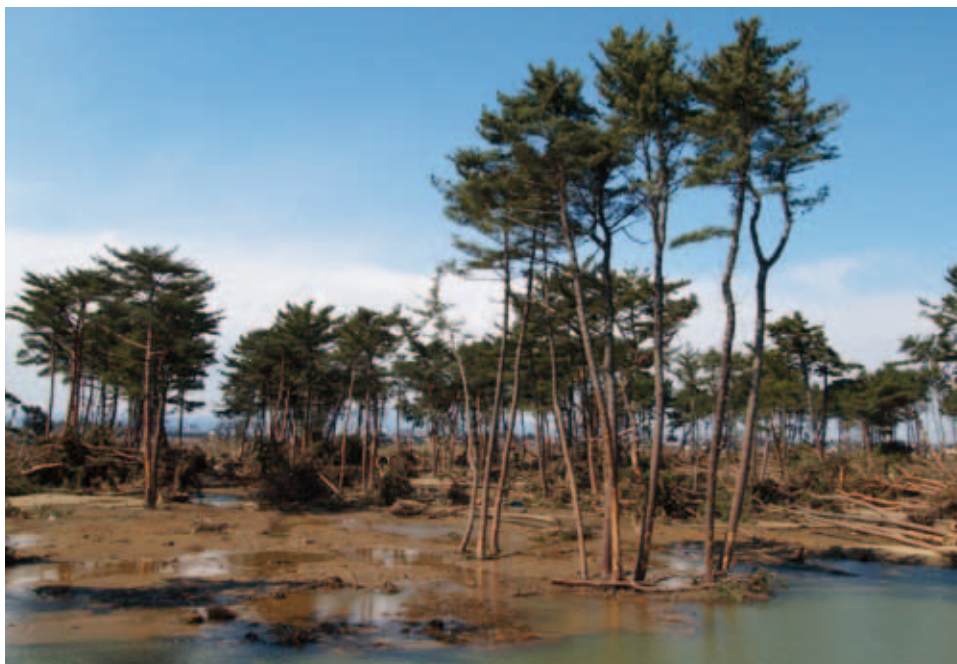
Photo 7

Uprooting (Sendai city, Miyagi Prefecture)

Uprooting continuously occurred from the sea side to the land side, leaving a strip-shaped forest zone such as after line logging. Water remained even 13 days after the tsunami, and the place was like wetland.

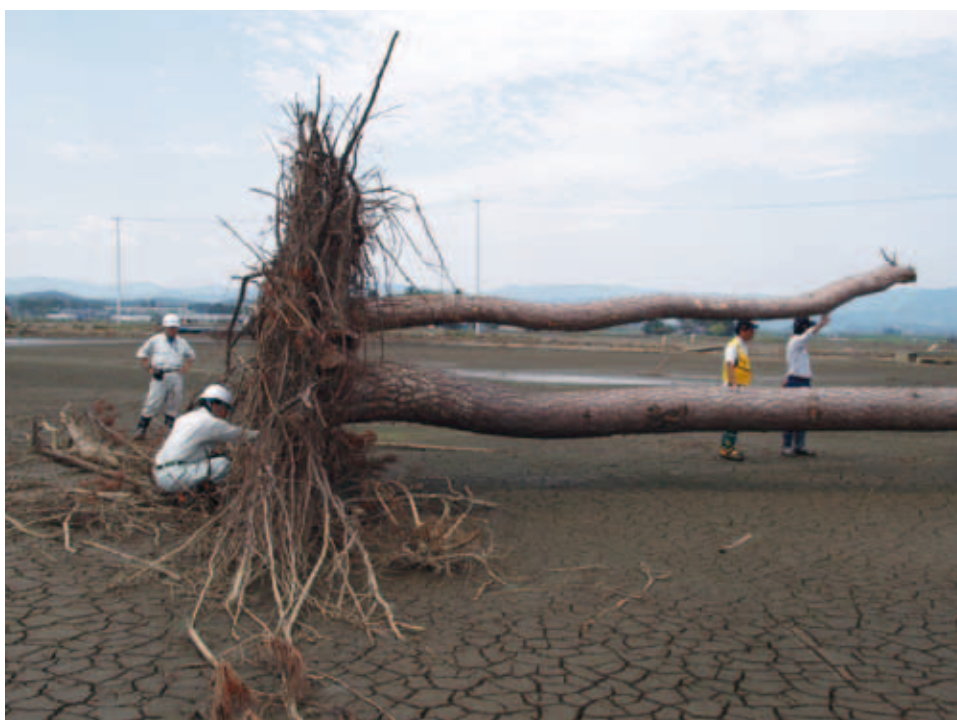
Photo 8

Root system of driftwood (Soma city, Fukushima Prefecture)

Many driftwood with roots had board-shaped root systems and sinker roots had not been developed.

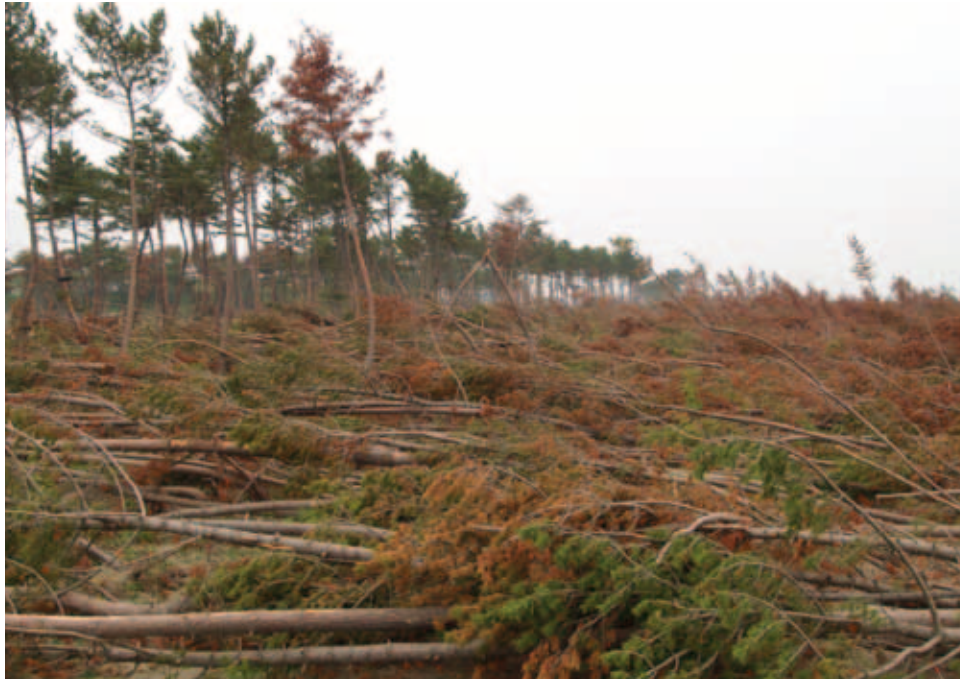
Photo 9

Coastal forest pushed down (Sendai city, Miyagi Prefecture)

Trees with stems broken at the base and those that underwent uprooting are mixed. Although the damage was devastating, trees were not necessarily washed away (thus did not become driftwood).

“Leaning” is a state wherein the stem is inclined (Photo 9). Causes of leaning include stem breakage near the base and uprooting. If the cause could be identified, the event was classified into either of these causes. However, the cause could not be confirmed to be breakage or uprooting in some cases because the basal part was covered with sand brought by the tsunami or blown sand accumulated before the tsunami; these cases were classified as “leaning.” Some trees were found to undergo both uprooting and stem breakage.

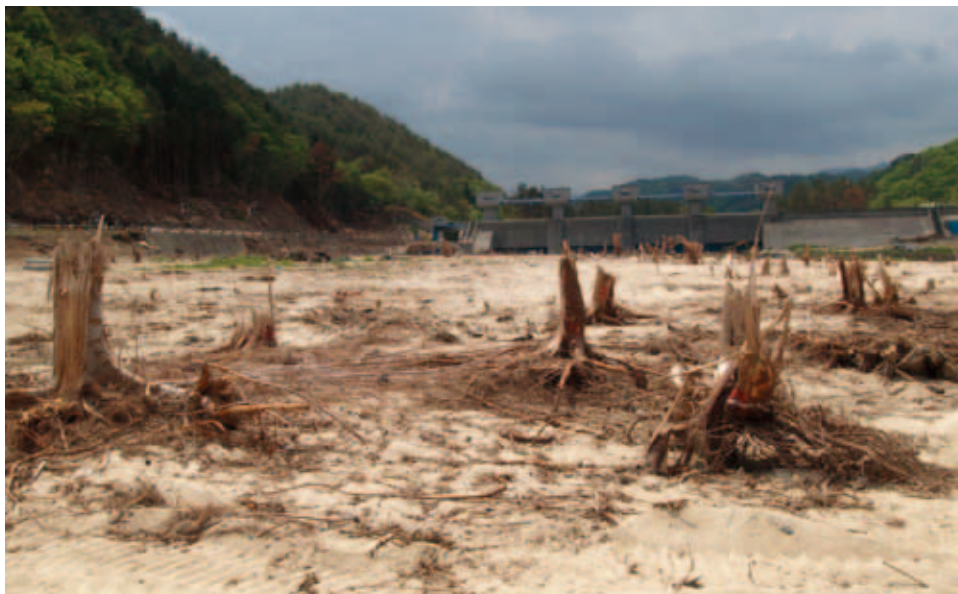
Photo 10

Stem breakage (Fudai village, Iwate Prefecture)

The breakage edge is complex, suggesting that breakage was not completed in a single strike.

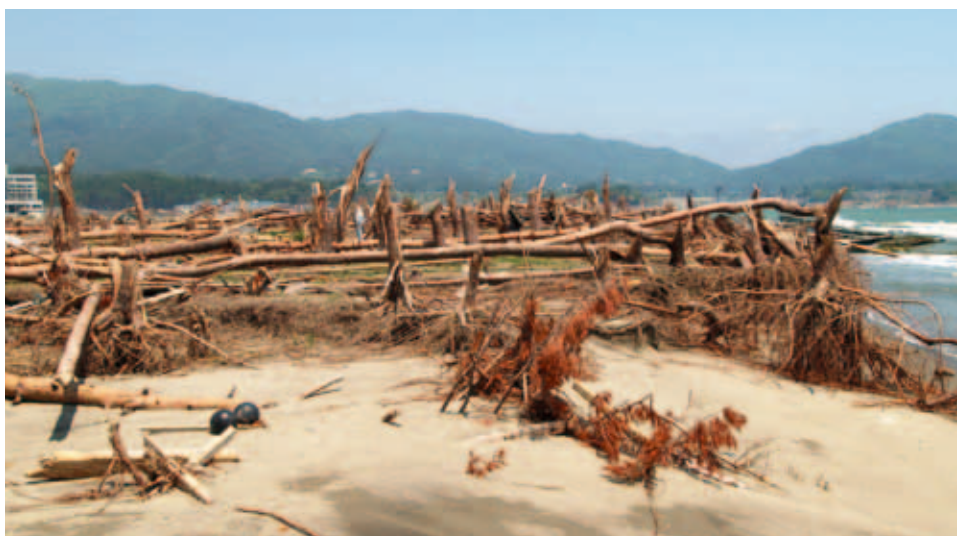
Photo 11

Stem breakage (Rikuzentakata city, Iwate Prefecture)

In Takata-matsubara, coastal forests were often lost along with soil, but stem breakage was readily noticeable where the soil remained. Washed-out roots had well-developed sinking roots.

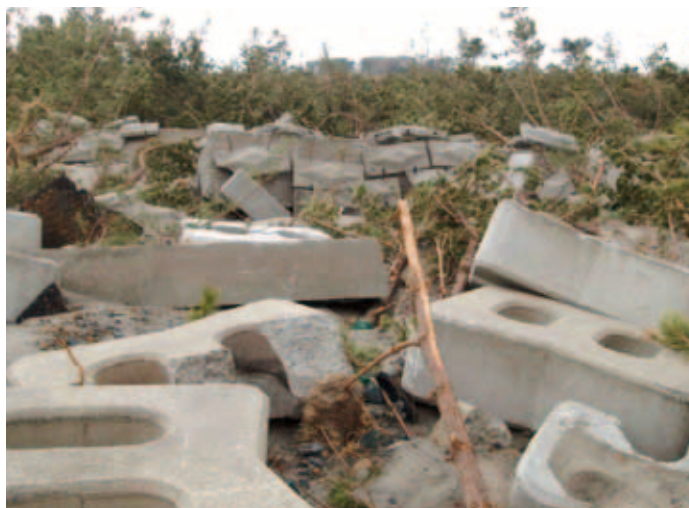
Photo 12

Concrete blocks scattered in forest (Natori city, Miyagi Prefecture)

Constituent materials (such as concrete blocks) of coastal levees destroyed by the tsunami became drifting objects and entered coastal forests. Coastal forests were severely damaged not only by the tsunami itself but also by these concrete blocks.

For example, in areas affected by the tsunami of present interest, concrete masses from coastal levees were scattered in coastal forests (Photo 12). If buildings had been there, these concrete masses could have directly struck them.

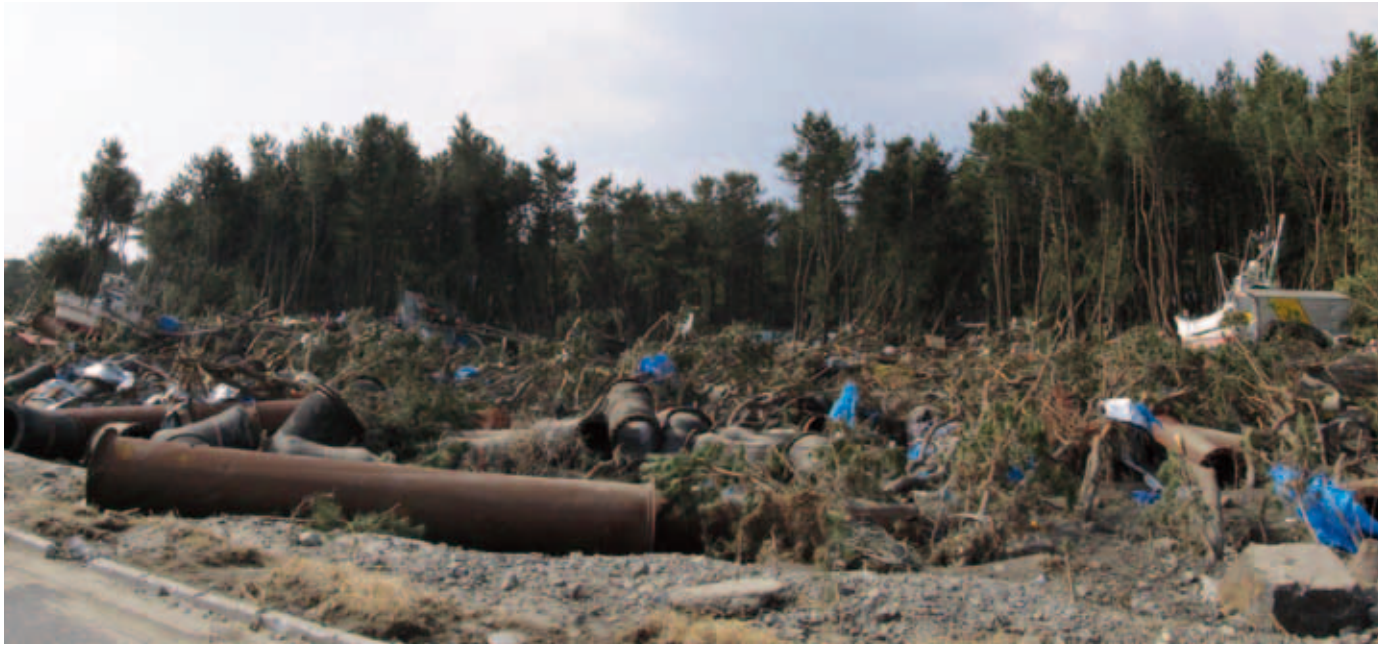
Photo 13

Drifting objects transported into coastal forest (Hachinohe city, Aomori Prefecture): provided by the Agriculture, Forestry and Fisheries Department, Aomori Prefecture)

Fishing boats and various other drifting objects entered coastal forests. From a different point of view, coastal forests captured objects drifting because of the tsunami and prevented them from being transported inland.

It is noteworthy that uprooting and stem breakage occurred not only from the power of the tsunami itself but also from impacts by tsunami-driven objects. For example, concrete blocks from broken coastal levees did not stay in place but entered coastal forests on the inland side. These concrete blocks then directly strike coastal forests and pushed down or damaged trees therein (Photo 12). In Ichikawa-cho in Hachinohe city, the coastal forest was possibly pushed down by such objects like fishing boats drifting into the forest (Photo 13; Sakamoto et al., 2012).

In this survey, a case wherein ships had been stopped by a coastal forest (Photo 13) and cases wherein concrete blocks from broken coastal levees and other drifting objects stayed in the forest although they had pushed down trees in the forest (Photo 2, Photo 3, Photo 12) were observed. Further, we observed a case wherein driftwood was trapped by the surviving trees (Photo 18).

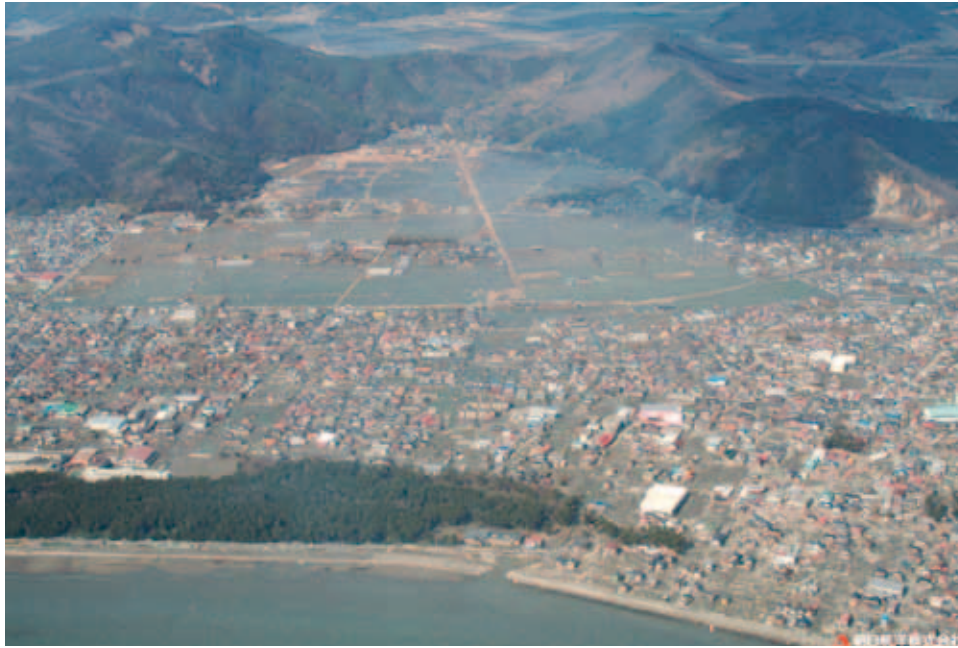
Photo 14

Surviving coastal forest (Ishinomaki city, Miyagi Prefecture: March 12, 2011, provided by Aero Asahi Corporation)

Surrounding areas, including those behind the coastal forest, were flooded, and many houses were washed away to the east of the coastal forest (at right in photo); however, damage to the forest was limited. However, many trees died later.

Moreover, in Nagahama in Ishinomaki city (Photo 14), land development for housing was suppressed owing to the presence of coastal forest; thus, the forest prevented potential damage to houses that could have been built there and damaged by the tsunami had the coastal forest not been there. Furthermore, it has been evaluated that the coastal forest prevented potential additional damage from these houses that could have occurred if they had been washed away, broken into rubble, and driven inland by the tsunami (Okada et al., 2012).

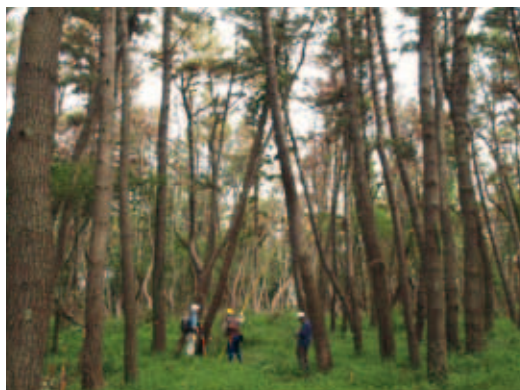
Photo 15

High clear stem height of surviving coastal forest (Ishinomaki city, Miyagi Prefecture)

Although the inundation depth was estimated to be nearly 4 m, it was believed that the tsunami passed between the stems and did not strike tree crowns (canopy layer), owing to the clear high stem height.

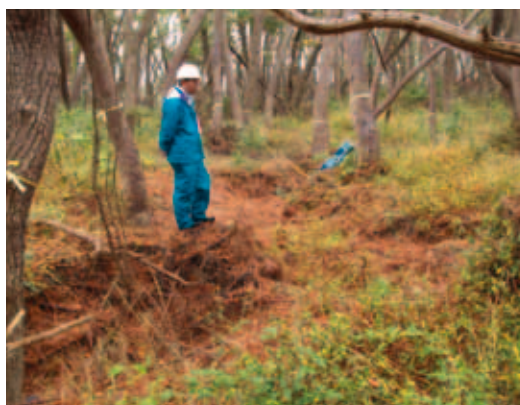
Photo 16

Scouring that occurred in surviving coastal forest (Ishinomaki city, Miyagi Prefecture)

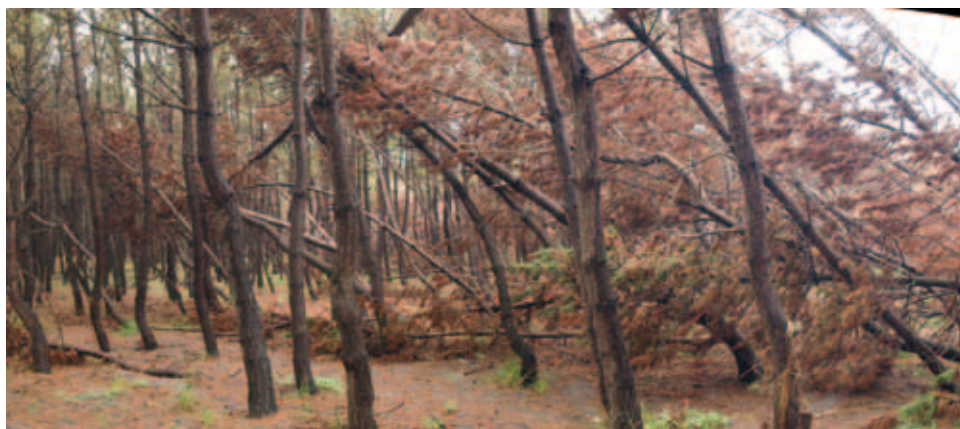
Photo 17

Leaning of coastal forest caused by the tsunami (Misawa city, Aomori Prefecture)

Although the coastal forest leaned toward the inland, leaning terminated in the middle of the coastal forest, with a clear boundary.

some places in which leaning of trees because of the tsunami was clearly confirmed to have stopped in the middle of a coastal forest (Photo 17). This fact suggests that the wave power was reduced while the tsunami was passing through the forest (Sato et al., 2012; Noguchi et al., 2012).

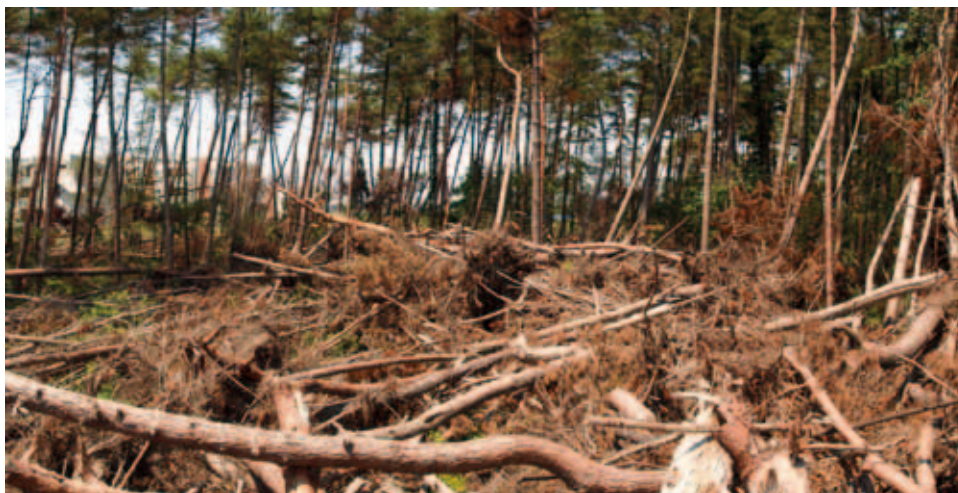
Photo 18

Deposition of driftwood (Iwanuma city, Miyagi Prefecture)

Part of the coastal forest was uprooted and became driftwood but was captured by trees on the inland side that did not undergo uprooting or stem breakage (rear of photo).
